# Managing visual amenity at Rutherglen Battery

## 1 What the Queensland planning rules require

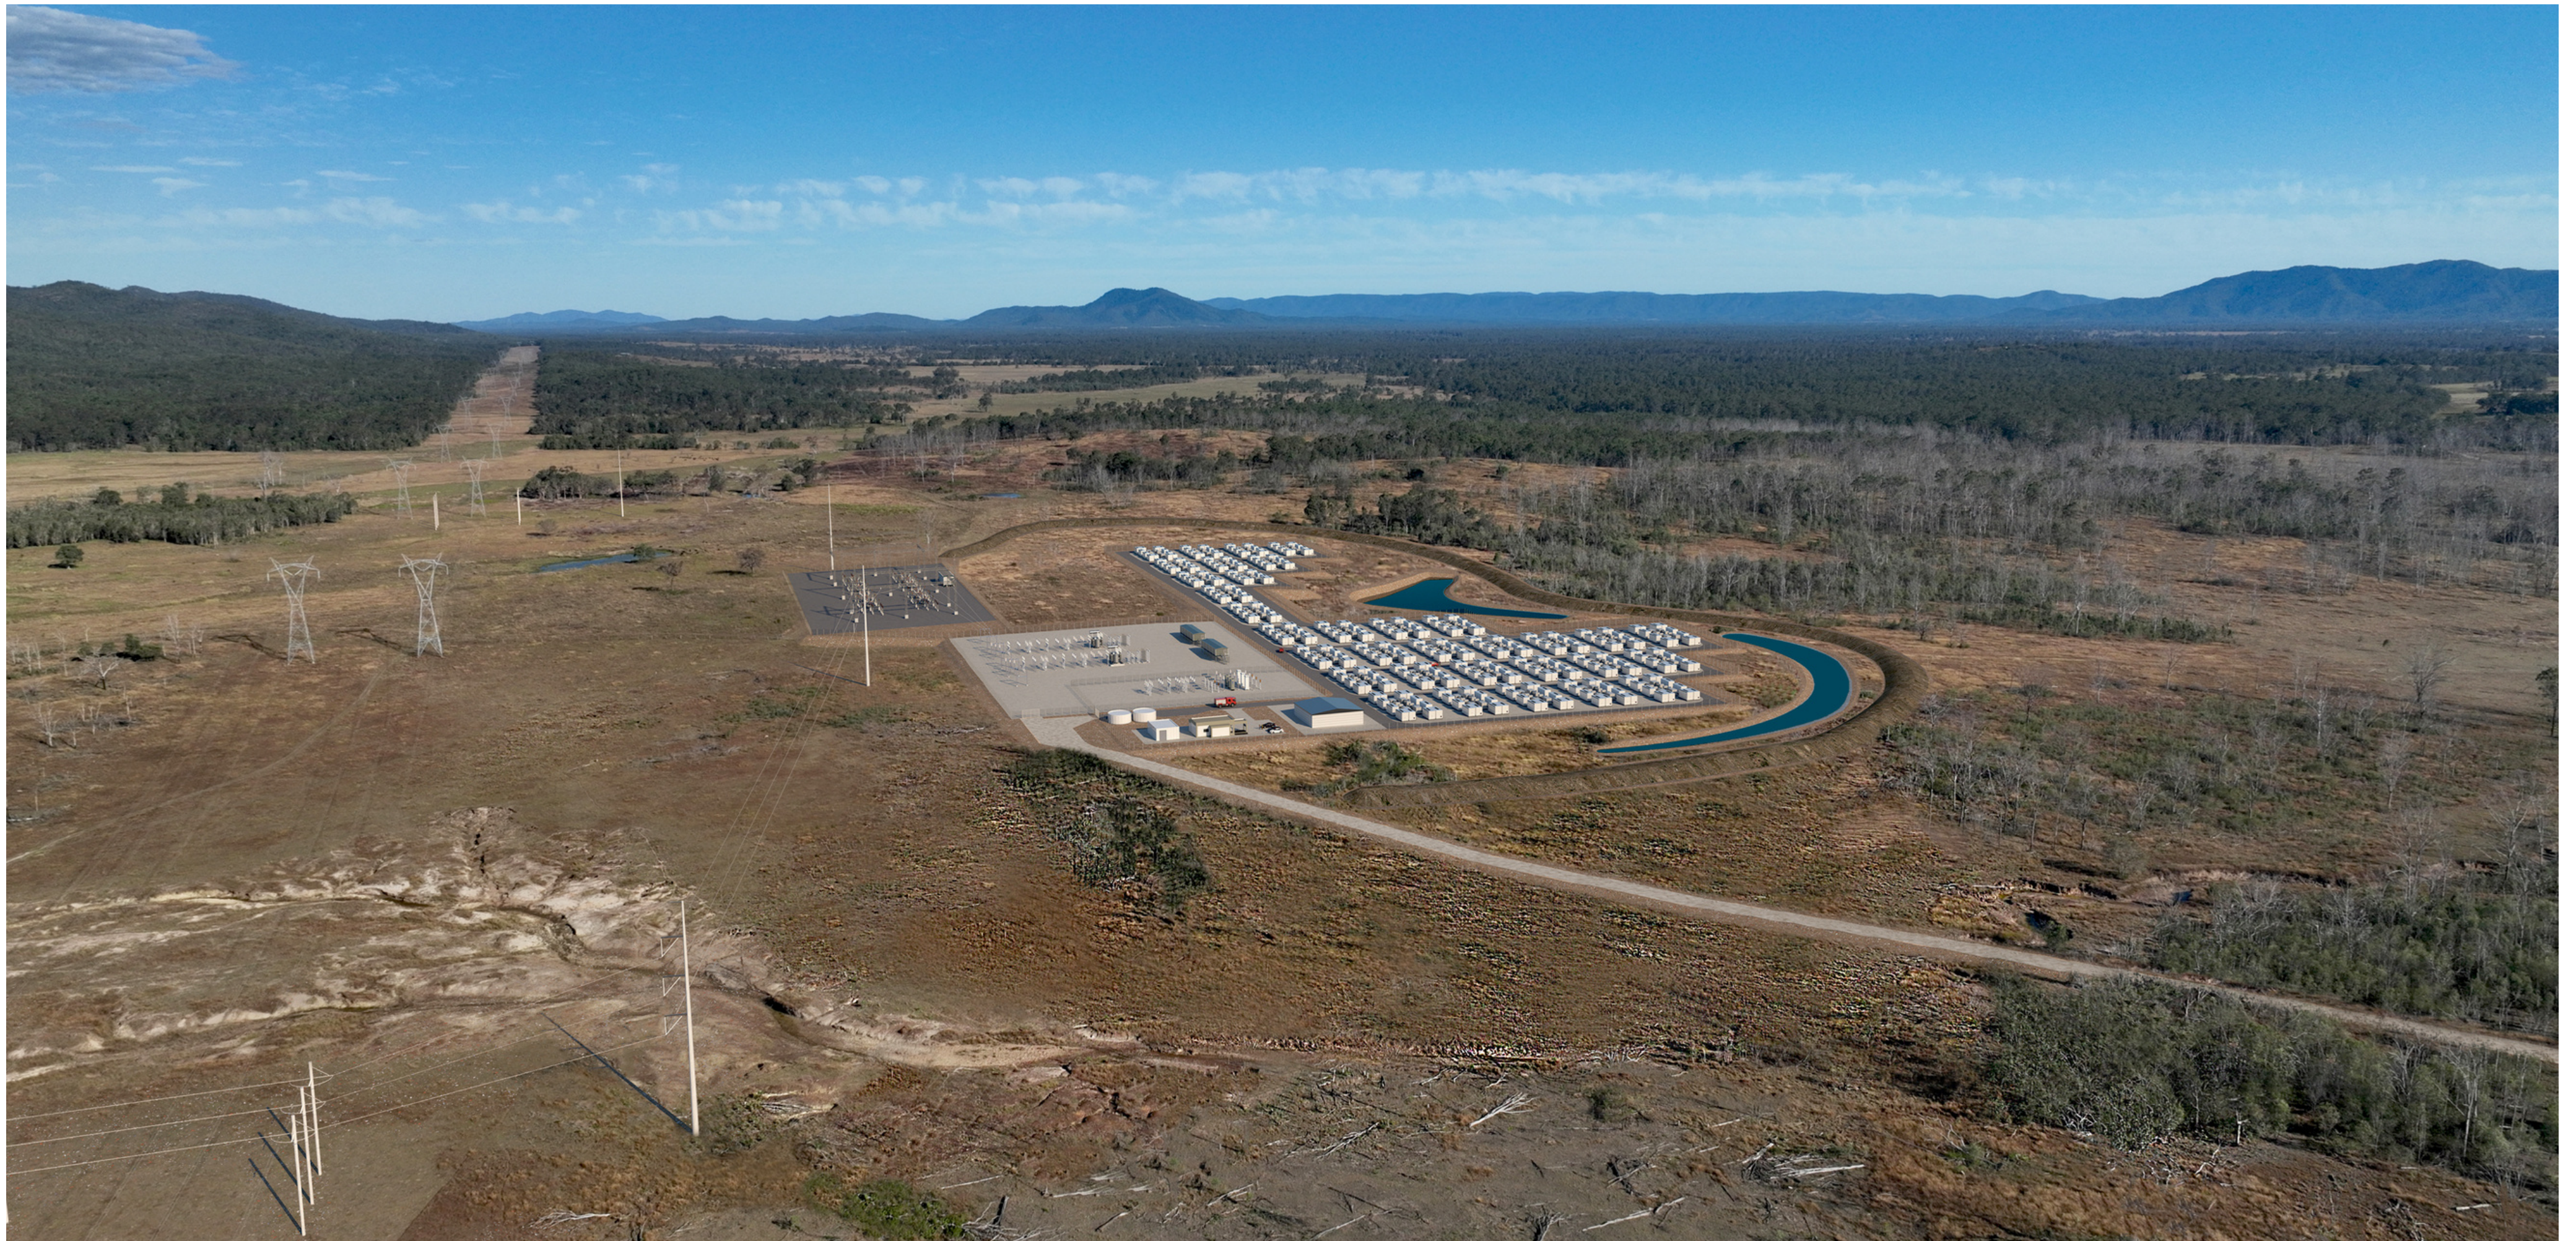
Artist render of the 22.8 ha footprint within the 1,277 ha property

- Careful siting.** The 22.8 ha footprint sits centrally within the 1,277 ha property, well back from the road and alongside the existing transmission lines.
- Vegetated grass berms 2.7 m high** along the northern and western sides will screen the battery from Red Hill Road.
- Berms built early.** Constructed before the battery is operational, so planting has time to establish. Formed from soil moved during site levelling.

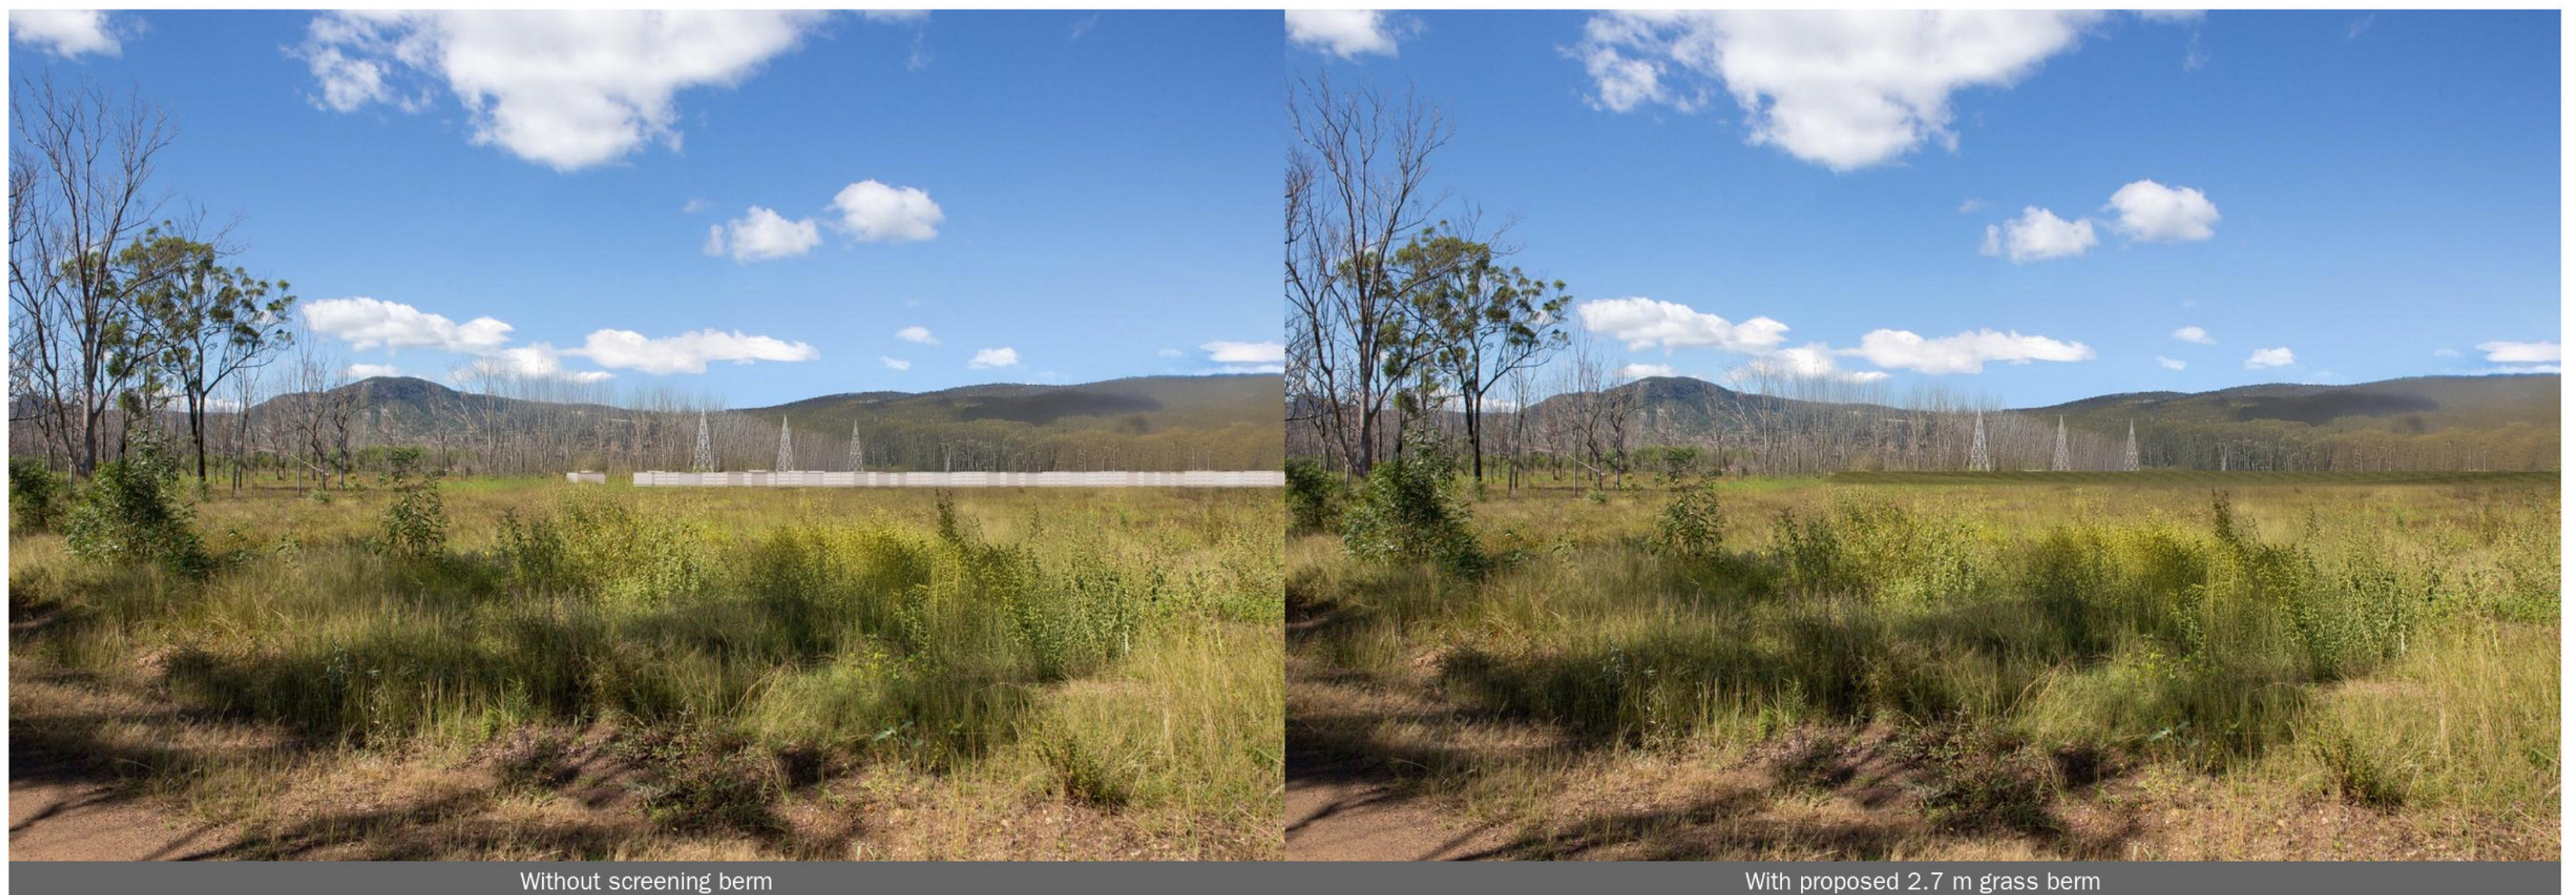
Location A — view from Red Hill Road (indicative photomontage)

The assessment concludes that, with the grass berm in place, no further visual screening or mitigation works are necessary, and that the proposal protects the values and scenic amenity of the surrounding landscape to the greatest extent feasible.

**Public views only from Red Hill Road** — a quiet unsealed road, about 50 vehicle trips a day. The battery is set back around 400m and screened by roadside vegetation.
